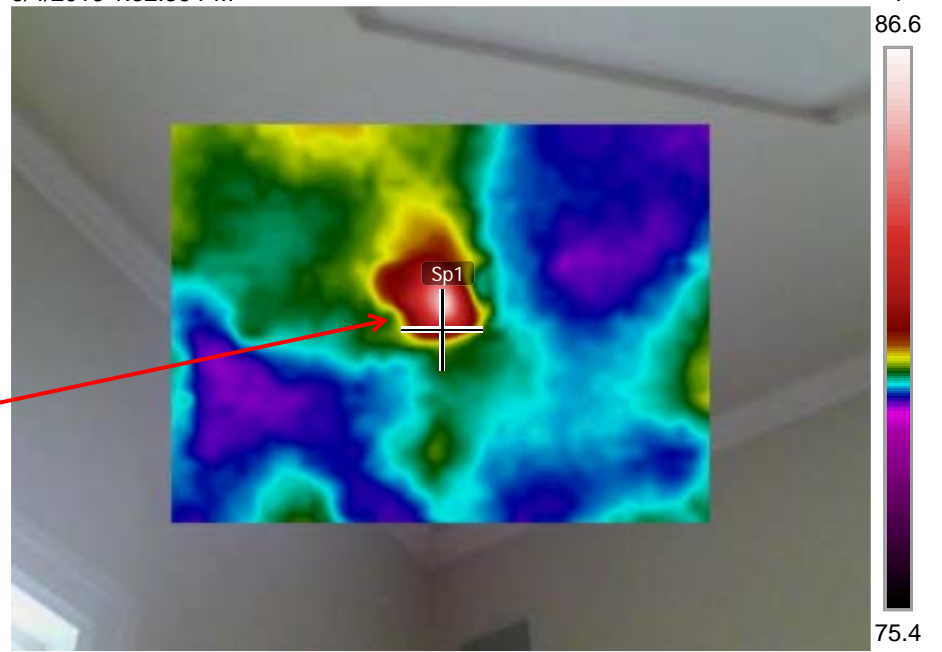
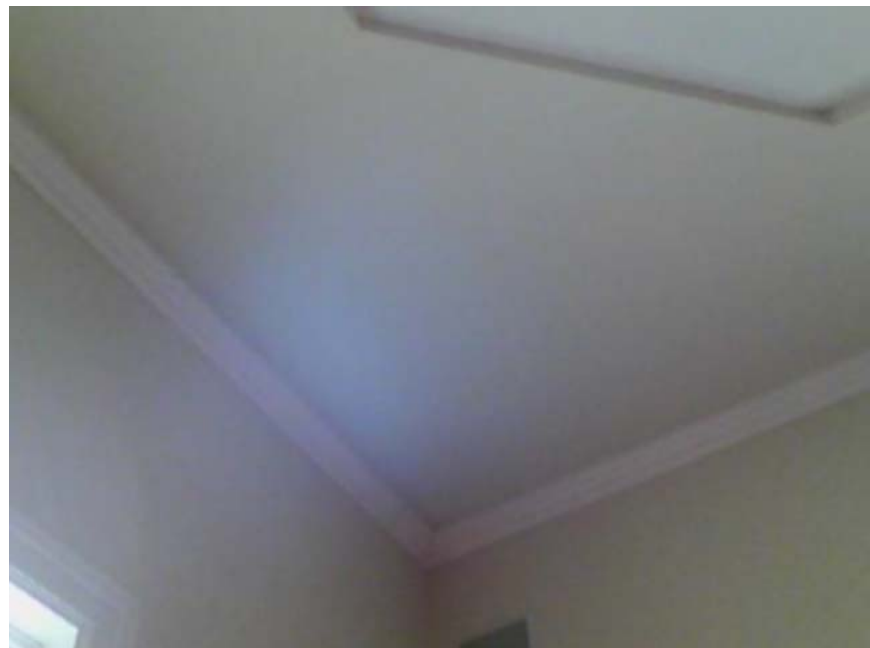
FLIR0083.jpg

Sp1	81.6
-----	------

An unusual indication of elevated heat behind sheetrock ceiling in Family Room. Possible recessed lighting fixture covered by sheetrock during construction.

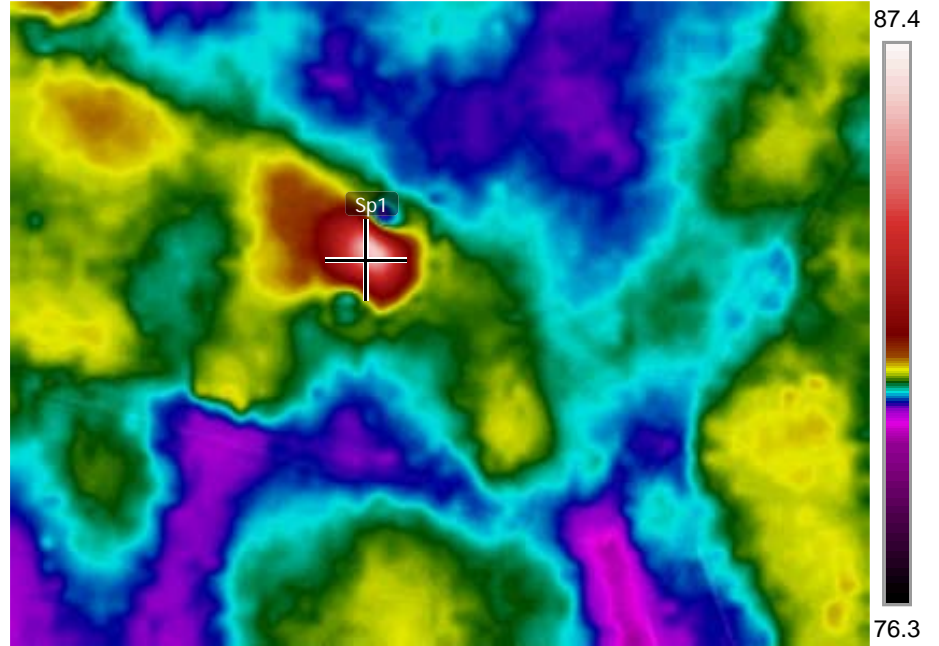
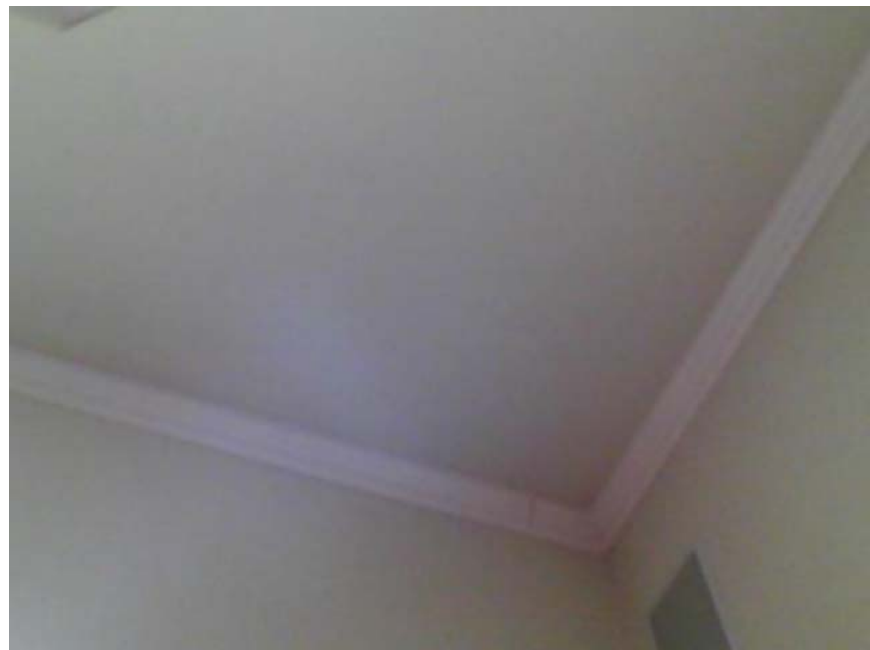
FLIR0084.jpg

Measurements		°F
Sp1	85.3	
Parameters		
Emissivity	0.95	
Ref. temp.	68 °F

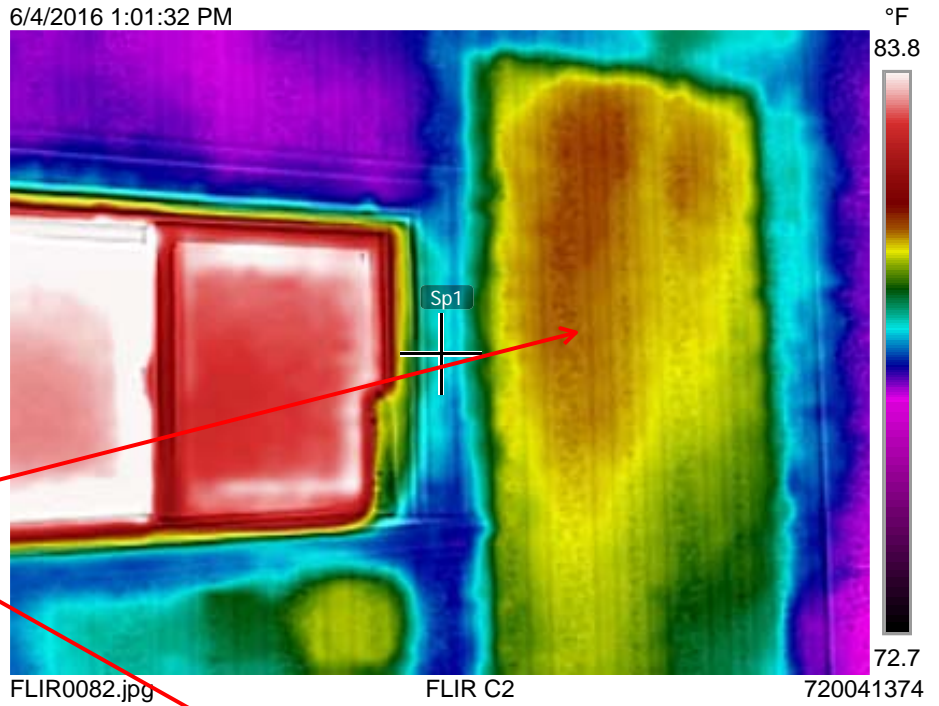
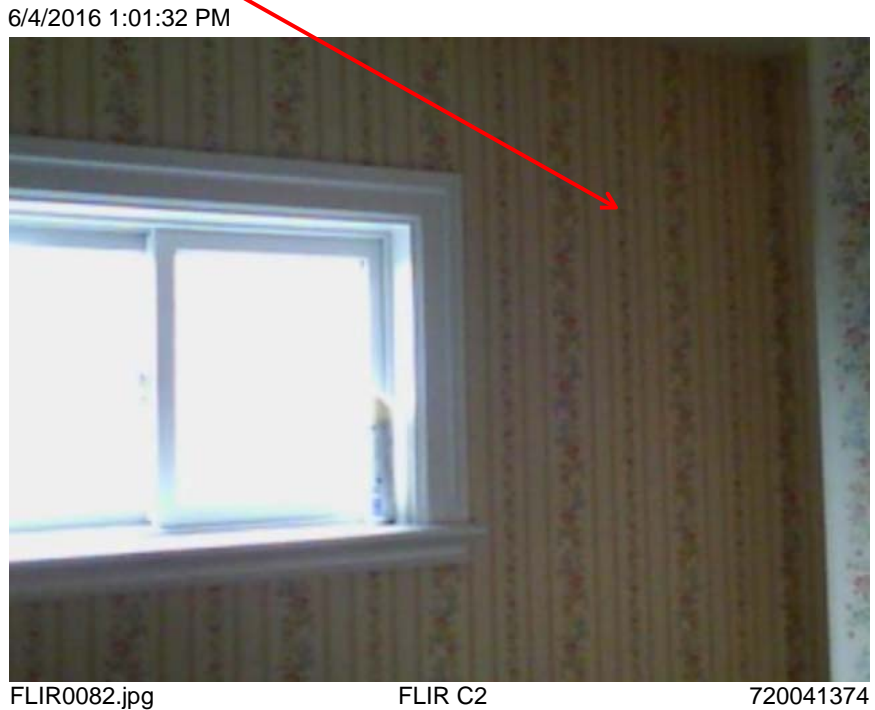
Measurements		°F
Sp1	78.8	
Parameters		
Emissivity	0.95	
Ref. temp.	68 °F

Little to no insulation in walls.

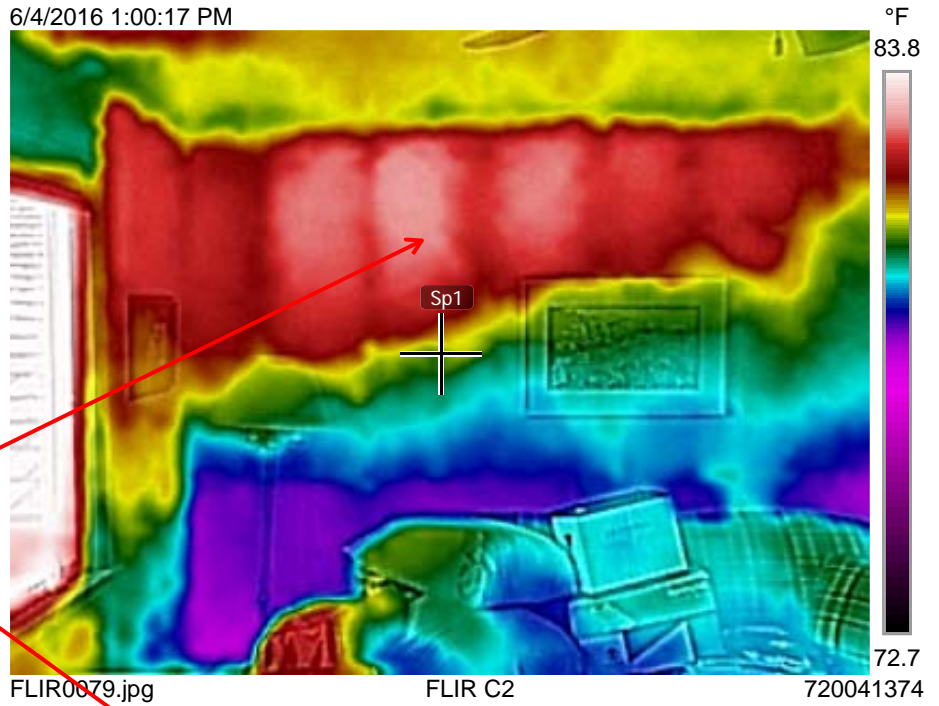
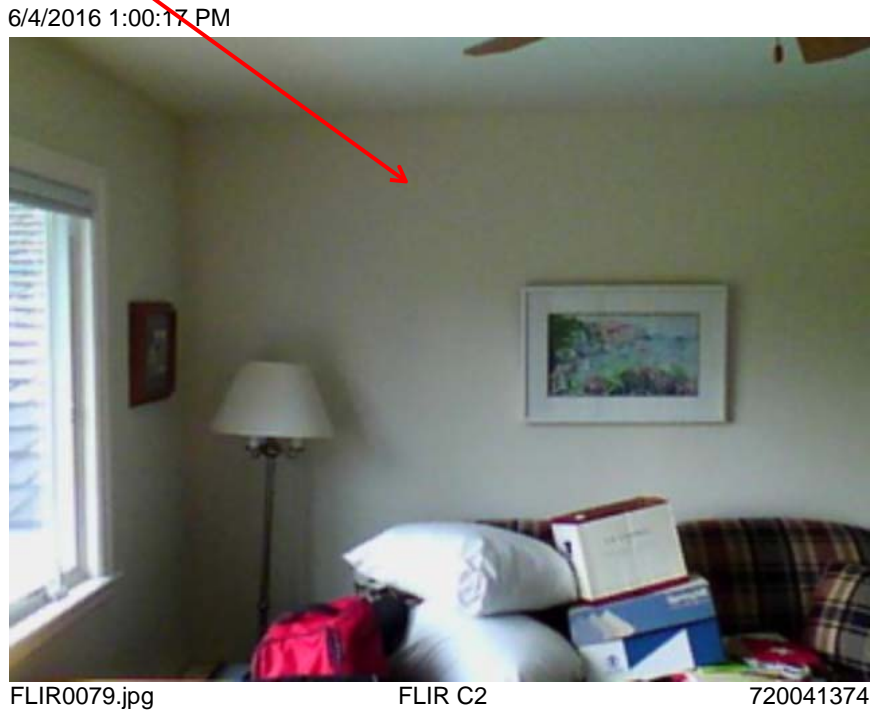
Measurements		°F
Sp1	80.6	
Parameters		
Emissivity	0.95	
Ref. temp.	68 °F

This area exposed to exterior with no insulation

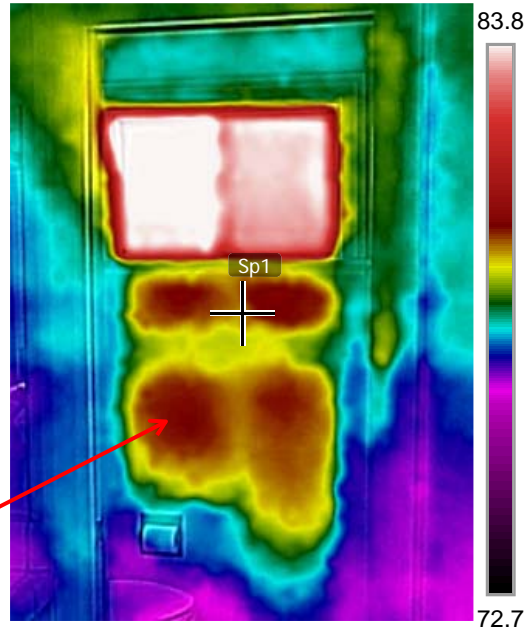
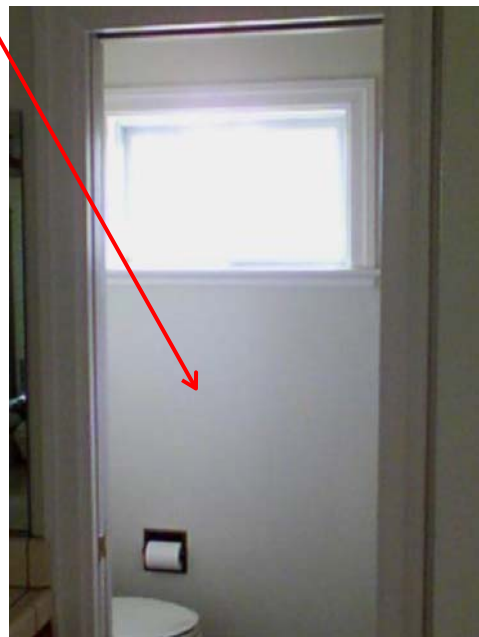
FLIR0078.jpg FLIR C2 720041374

Sp1	79.7
-----	------

Example of no insulation.
